# Manhole Inspection Summary

Manhole # S31GG2019MH

**Location** Address: **137 FIRESIDE CIR**

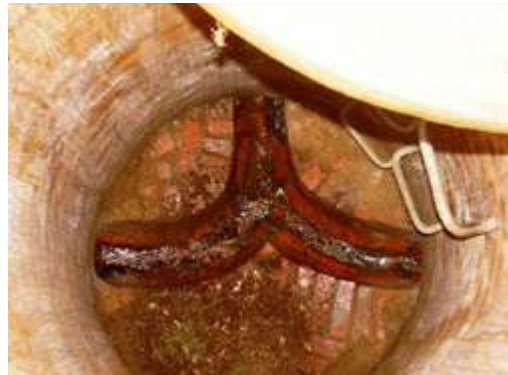
Top View

☐ Parged ☒ **Debris** (not Condition related)

☒ **Debris** (not Condition related)

Bench debris.

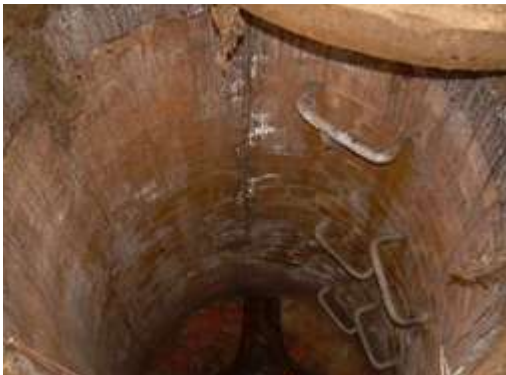
Defect

Infiltration: ☐ None ☒ **Joint** ☐ Cracks ☒ **Mortar** ☐ Roots ☐ Wall

Infiltration: ☐ None ☐ Joint ☐ Cracks ☐ Mortar ☐ Roots ☒ **Wall**

Adjustment, Corbel, and Barrel infiltration.

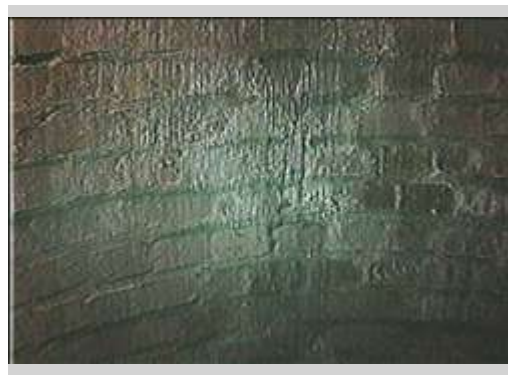
Defect

Infiltration: ☐ None ☐ Joint ☐ Cracks ☒ **Mortar** ☐ Roots ☒ **Wall**

Barrel infiltration.

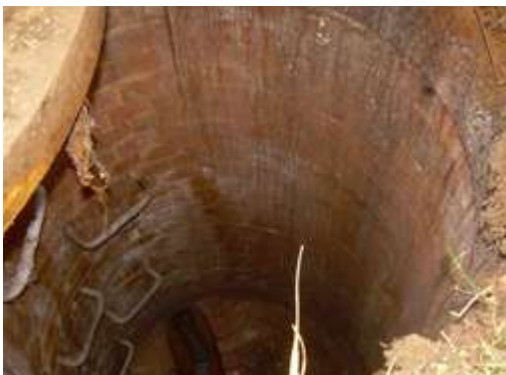
Defect

Adjustment and Barrel infiltration - other side.

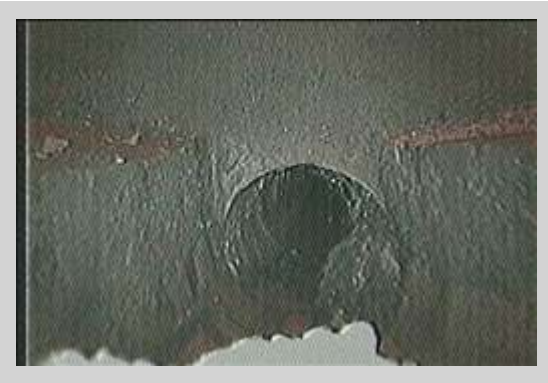
### 8 in. Circular Gravity Sewer Pipe Out @ 12 O'Clock

Condition: ☐ Sound ☐ Cracked ☒ **Root Intrusion** ☐ Deteriorated ☐ Leaks ☐ Debris

Channel root intrusion.

Infiltration: **None** Pipe Seal Cond: **Roots**
